A Report on Field Exposure Tests of Five Types of Reflective Sheeting Material

February 1958

State of California
Department of Public Works
Division Highways
Materials and Research Department

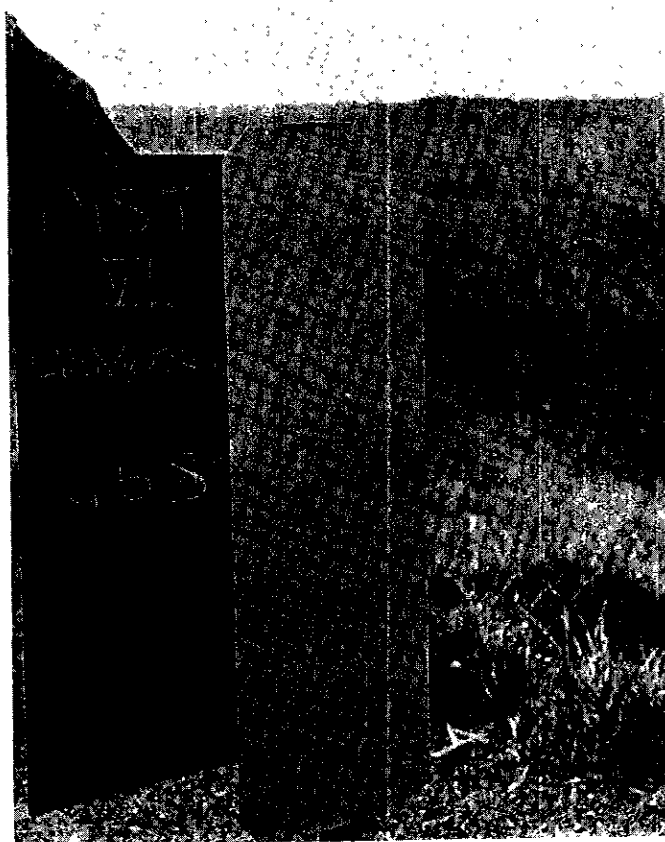
Fig. 4 Grote Silver
Undamaged - Peeling
on top edge after 8
months exposure.

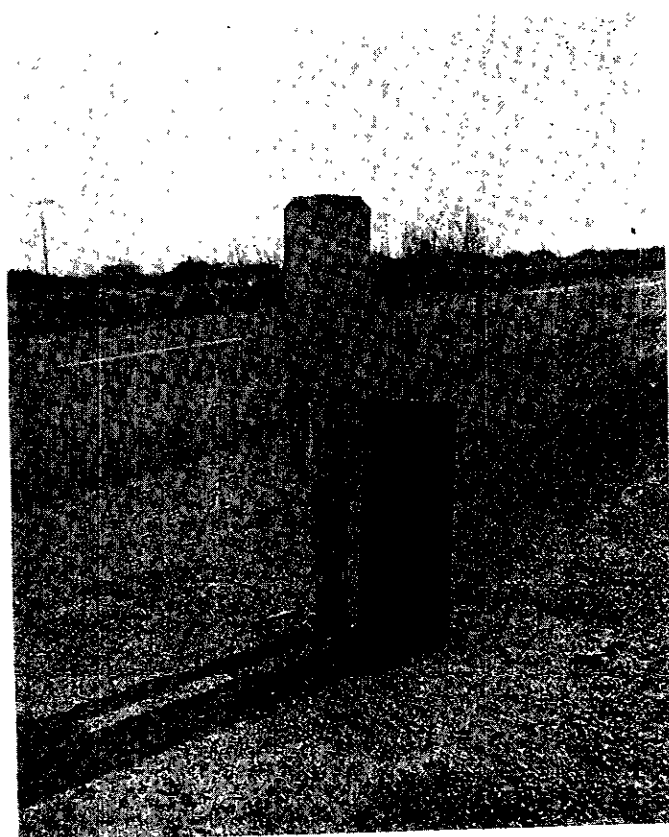
Fig. 5 Grote
Silver, Damaged -
Peeling on top
edge after 8
months exposure.

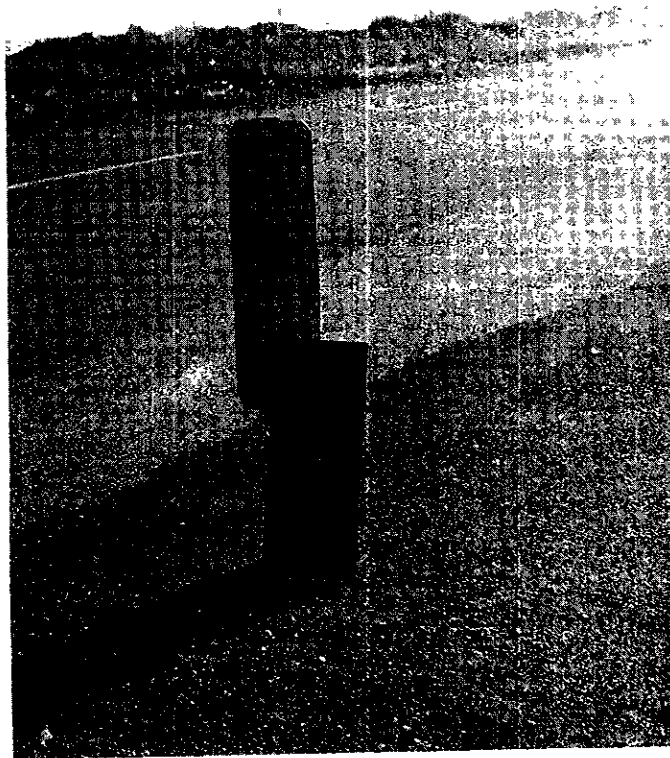
Inspection after nine months revealed that the panels at the valley roadway test site had been carved upon by vandals (see Figure 6); however, no peeling or further damage had resulted from this carving. The panels in the desert test site located on Palm Springs Highway 187-D were in good condition. They had not been subjected to the severe sandblasting prevalent in other desert areas. Signal Silver and red panels in the Coastal area had faded slightly.

Fig. 6 Example of Vandalism.

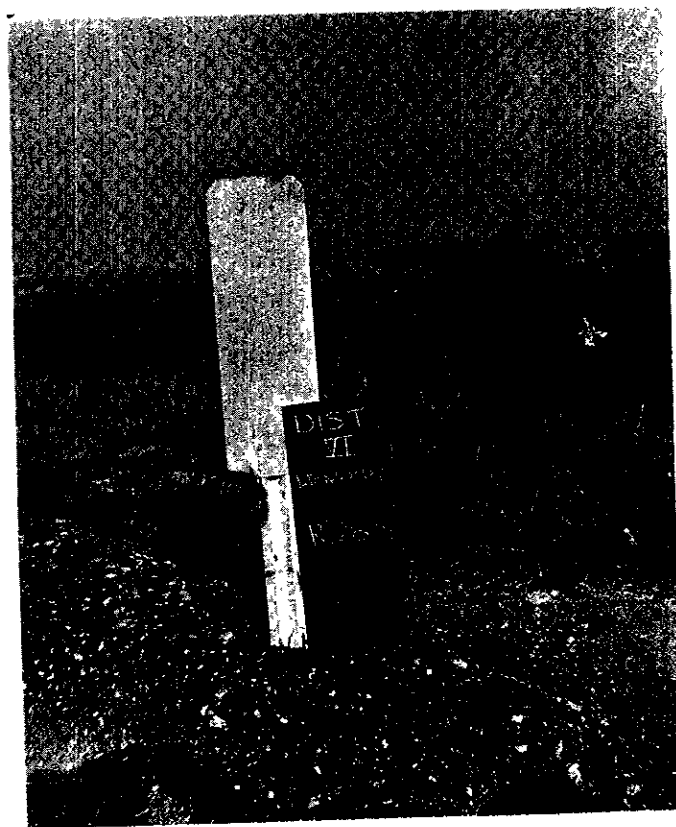
Reflexite panels in all areas were very brittle. They shattered easily when struck and were impossible to repair (See Figure 7).

Fig. 7 Reflexite Shattered from vehicle impact.

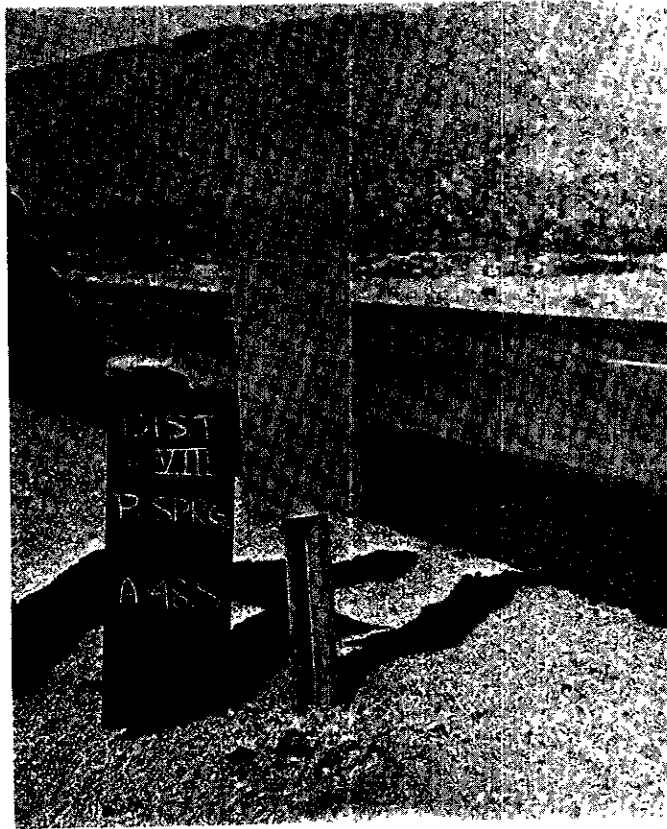
After nine months the panels in the valley and desert test areas were gray and dirty (see Figure 8). They did not respond to cleansing efforts when subjected to severe scrubbing and brushing. The coastal area Type F panels showed definite indications of failure due to exposure. The beading had weathered off, the panels retained road dirt, and the colors had faded extensively.

Fig. 8 Fre-lite -
Dirty and difficult
to clean.

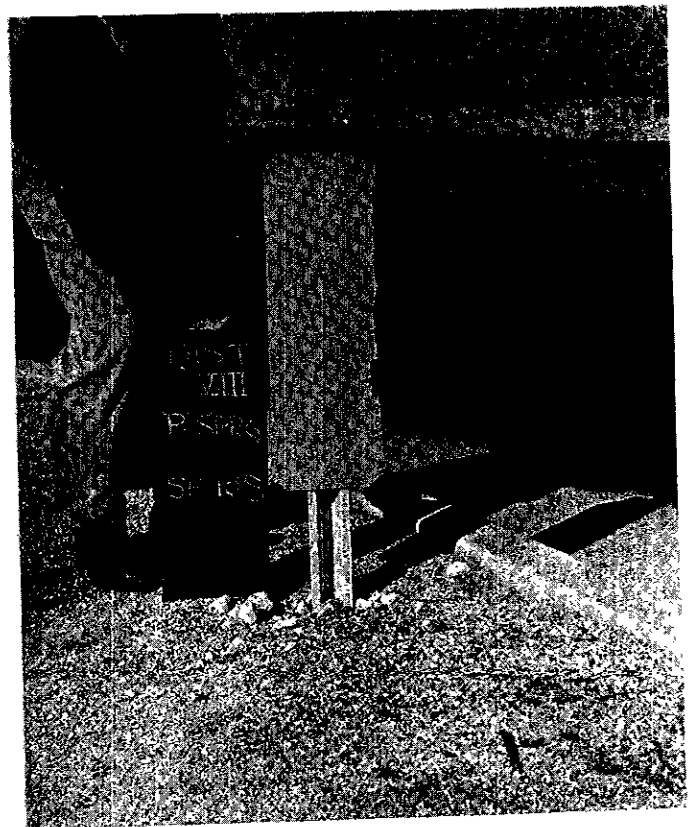
After nine months the south exposed panels at the desert test area were peeling along the edge (see Figure 9). The exterior layer of beading was peeling off the aluminum foil backing of the reflective sheeting. Panels in the coastal and valley test areas had weathered satisfactorily.

Fig. 9 Scotchlite
Flat Top - Peeling
along edge.

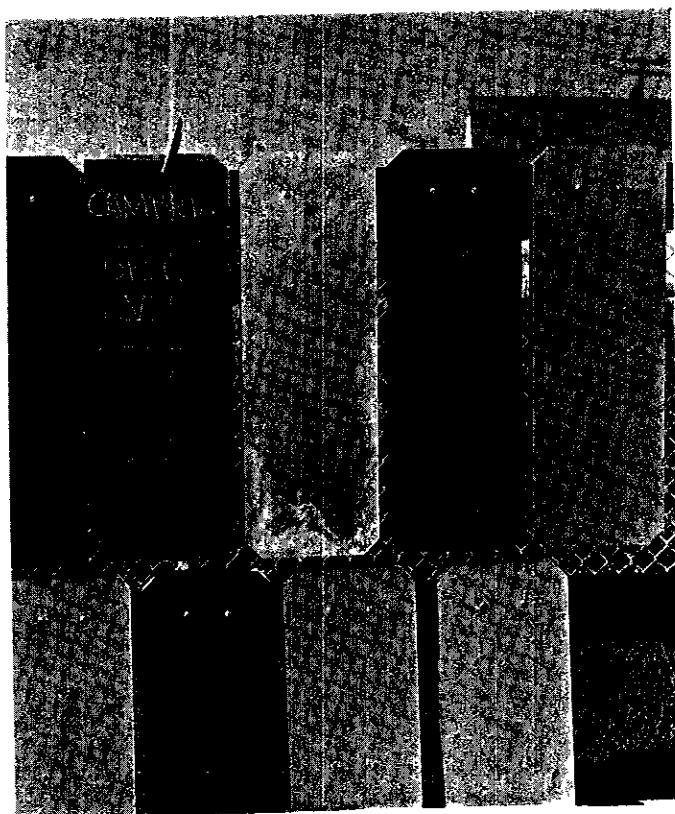
After nine months this reflective sheeting gave definite indications of failure due to exposure in all three locations. The panels had cracked and peeled between the plastic reflective surface and the aluminum foil backing. The exterior coating on the valley test area panels, particularly those in north exposures, had cracked and peeled (see Figure 4). The panels in the desert area had peeled and cracked slightly around the edges and along the bottom, apparently because of moisture. The reflective sheeting in the coastal maintenance yard had peeled off the aluminum base plate (see Figure 10).

Fig. 10 Grote Silver - Peeling severely.

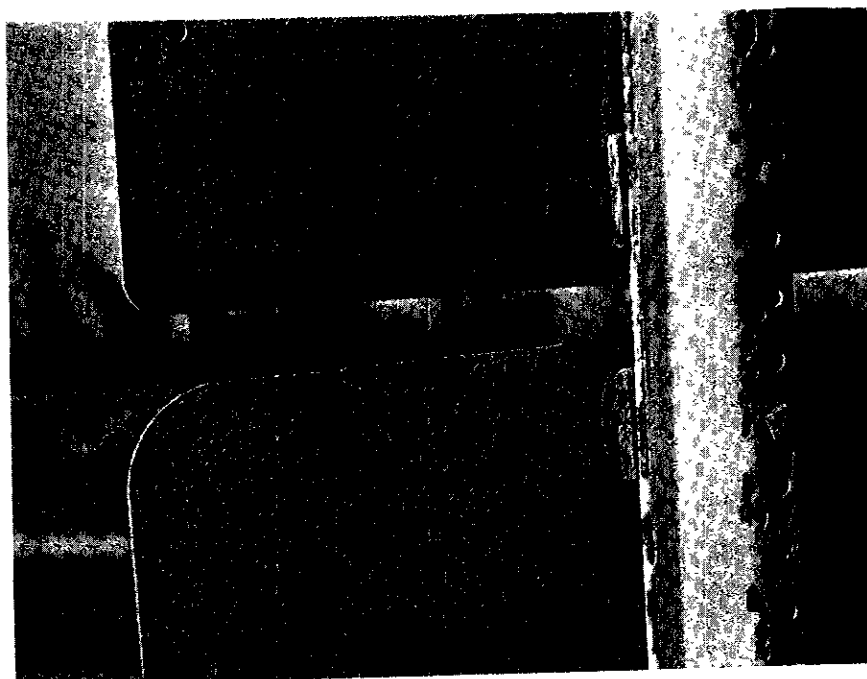
Fig. 11 Example of corrosion of aluminum backs - Huntington Beach area.

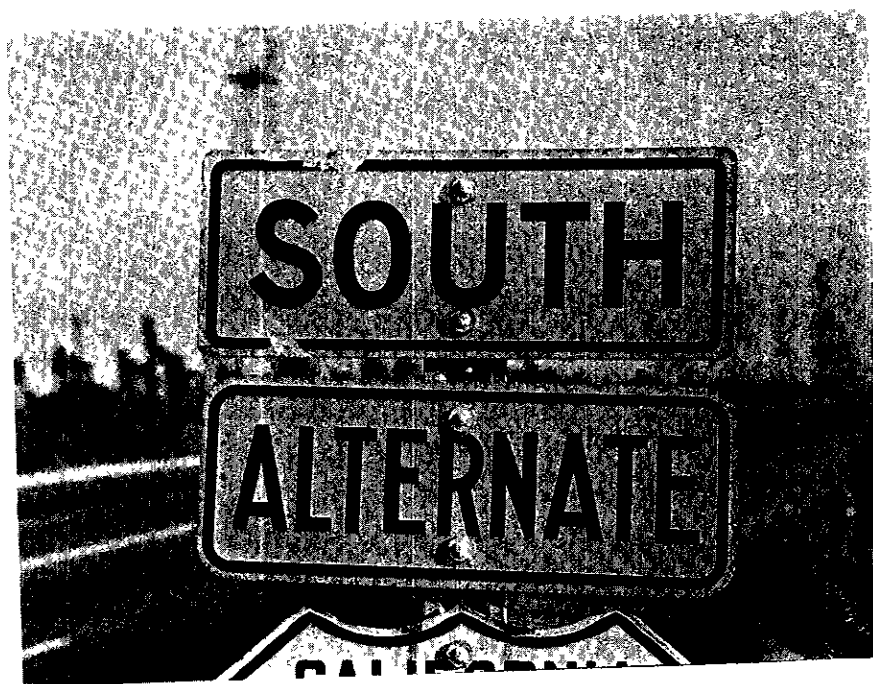
After nine months' exposure, the panels in the coastal maintenance yard had started peeling. Figure 12 indicates edge peeling which occurs on reflective sheeting in this area. Light corrosion was evident on the aluminum base plate. Panels had peeled and blistered more in the coastal area than in the other areas. The cause was primarily oxidation of the aluminum base plate under the sheeting rather than a deficiency in the reflective sheeting.

Fig. 12 Example of edge peeling of reflective sheeting.

After sixteen months' exposure the aluminum base plates had oxidized extensively. If aluminum base plates are installed in coastal areas, some sealing or protection to deter this oxidation will be necessary.
